FINAL
FOCUSED REMEDIAL INVESTIGATION/FEASIBILITY STUDY, OPERABLE UNIT 4,
FORMER MARCH AIR FORCE BASE/AIR RESERVE BASE, CALIFORNIA

JULY 2004

EARTH TECH
1461 EAST COOLEY DRIVE, STE 100
COLTON, CALIFORNIA 92324

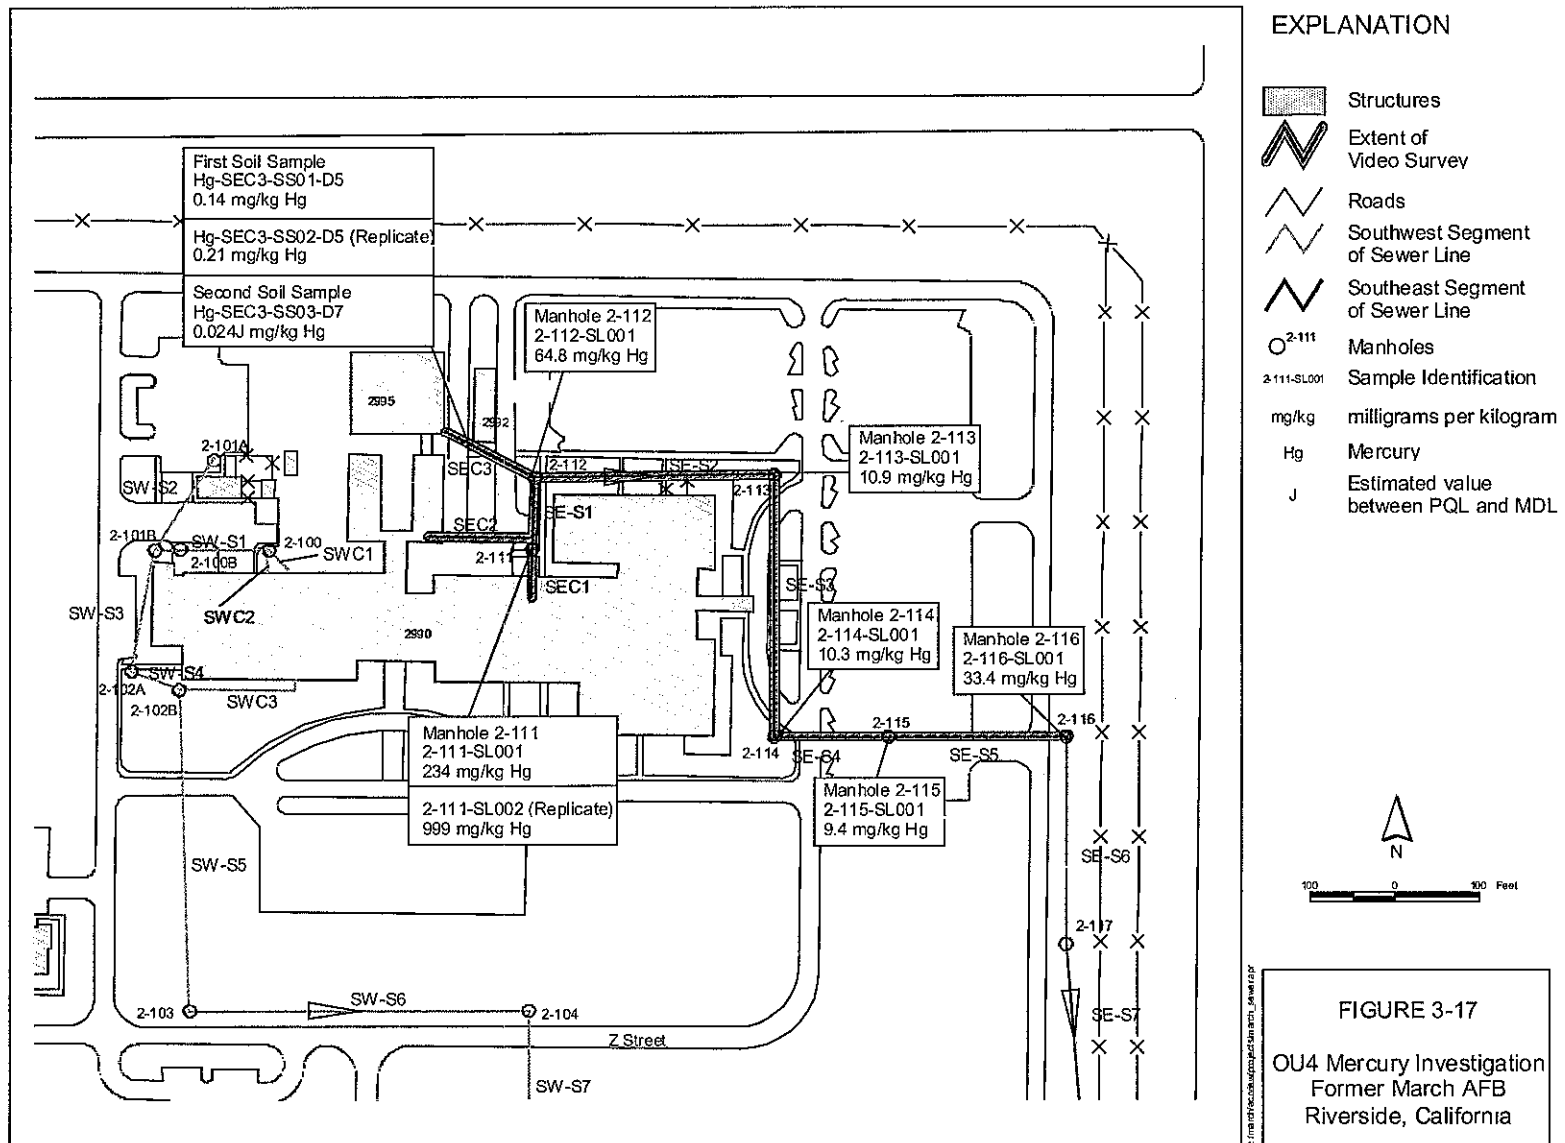
Based on the sludge sample analytical results, a video survey was conducted on the section of sewer line that contained mercury concentrations above PRG levels for residential soils. The videoed section started at manhole 2-111 on the southeast side of Building 2990 (including the lines identified as SEC 1, SEC 2, and SEC 3 that connect to the building) and continued through to manhole 2-116 (see Figure 3-16). The selected pipe section was cleaned in advance of the video camera to allow passage of the video equipment, and to enhance the visual inspection for potential leaks. A vacuum truck was employed during the cleaning process to capture the liquid waste generated during the process. A plug was installed at the effluent end of manhole 2-116 to prevent the passage of wastewater to the lifting station. The vacuum truck collected the wastewater from manhole 2-116 where the plug was installed. The wastewater was transferred to an on-site Baker tank once the cleaning process was complete. An Omni-Eye 3, tractor-mounted, high-resolution video camera with pan and tilt capability on a flexible lead was used to survey the sewer line section. A videotape of the camera inspection was provided along with an inspection report of the sewer lines surveyed. This video survey identified only one location where a potential leak source was identified in sewer line segment SEC 3. A circumferential crack at a joint from 3 to 7 o'clock. The crack was 78.52 feet from manhole 2-112 towards the Dental Clinic (see Figure 3-16 for crack location and soil results).

Two subsurface soil samples and a replicate sample were collected directly underneath the section of the sewer line (SEC 3) where the crack was located. Because the samples were collected from soils directly underlying the sewer pipe, a 60-degree angled borehole was used to reach the desired sampling point without damaging the pipe. Since the depth to the bottom of the sewer line was estimated at 3 feet 5 inches bgs, a hand-held power auger was used to advance the auger hole more rapidly and easily than augering the entire depth by hand.
